## AVIATION INVESTIGATION REPORT

A05Q0119

### COLLISION WITH WATER

BELL 205 A-1 HELICOPTER C-GADA

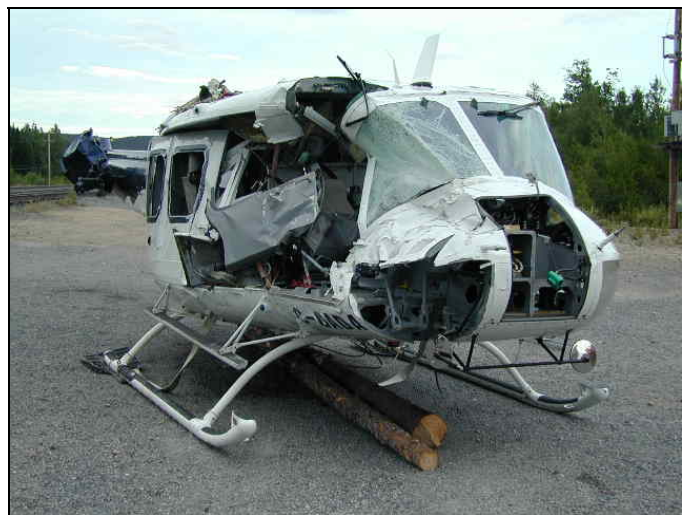
The helicopter came to rest inverted approximately 1000 feet from shore in about 25 feet of water and silt, which totally obscured the water during salvage operations. The initial attempt to retrieve the helicopter by the cargo hook resulted in the lift beam being torn off and lost. The water bucket, the tail rotor, and all parts that had been separated from the airframe could not be located due to the lack of visibility under water. Once the helicopter was recovered, examination of the airframe confirmed a nose-down impact on the right side (Photo 1).

**Photo 1.** Damage to Bell 205 A-1, C-GADA

The main rotor blades had been severely damaged from impact with the water. Signs of delaminating of the re-enforcing straps near the blade roots, usually associated with blade coning, were not present. Coning is the result of upward blade movement if rotor rpm decays following a loss of power and application of collective. The examination revealed that the impact loads had also broken the four main transmission pylon mounts. The transmission remained attached to the airframe only by the hydraulic lines and the flight controls. During the impact, the rotor head contacted the mast. The mast was disassembled and examined; no pre-accident condition, which could have been causal to the accident, was revealed. The main power shaft between the engine and the transmission was a KAflex type. Only the connectors to the engine and transmission were recovered, with some of the flexible segments still attached. All fractures associated with the KAflex were examined and found to have resulted from overload. The hollow portion of the shaft grooved a circular imprint of the shaft ends on both the connectors. This could only have occurred if the shaft assembly had remained in position until impact.

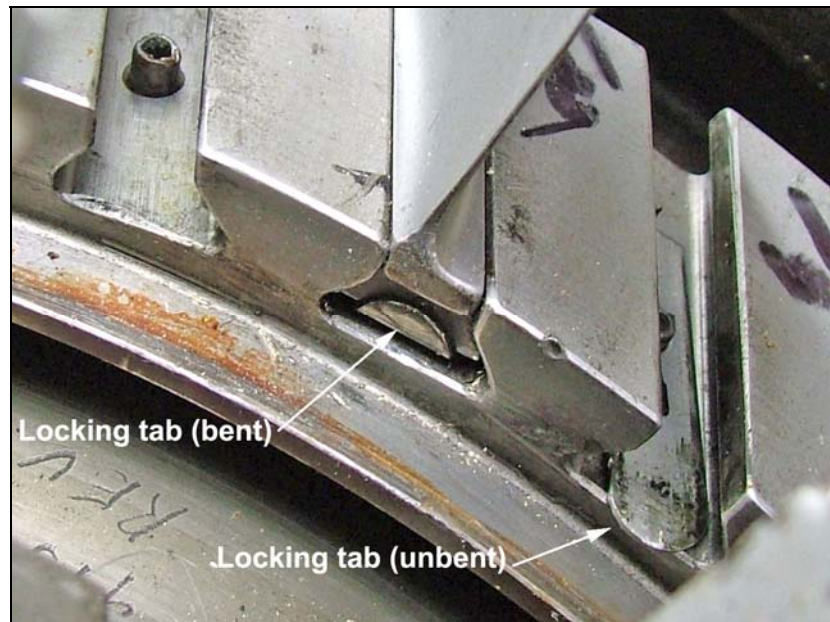
There are 31 blades (part number 1-100-361-06) on the first stage compressor disk. Each blade has a locking tab (part number 1-100-505-02). These are single use only items and should be replaced at each disassembly. The examination revealed that all the locking tabs, locking the blades to the first stage compressor disk, were found unbent (see Photo 2). All of the blades had moved back and there was rotational scoring on all aft blade platforms, with corresponding damage on the outer diameter of the vane support.

The disassembled engine was returned to the TSB Engineering Laboratory. The additional test results are outlined in report LP 046/2006 (Testing of Locking Tabs). The report shows that a calculated rearward acceleration in the vicinity of 2034 g would have been required to unbend the tabs. The relatively low impact sustained by the helicopter, the forward direction of the helicopter during the impact, and the observations made during the testing suggest that it is unlikely that the first stage compressor blades moved aft during the accident, unbending the tabs. It is likely that the tabs were not replaced and bent, as required, during the last maintenance conducted on the compressor (Photo 2).

Photo 2. Locking tabs

Extensive examination of the engine and FCU did not reveal any anomaly or defect that could have contributed to or caused a loss of power to the engine. The locking tabs on the first stage of the compressor had been left unbent at the last engine overhaul. Except for having a high potential for engine mechanical or structural damage, the backward movement of the compressor blades had no effect on the engine operation during this event. Other than not being certified for use in civilian-registered helicopters, the presence of unauthorized parts also had no effect on engine performance. The finding of unbent locking tabs and unauthorized parts indicates a lack of quality control on the part of both maintenance facilities involved. Because military and commercial parts may have the same part number, it is essential to cross-reference the CAGE code of the parts so as to trace their origin and confirm their authorized use in commercial aircraft. The lack of a CAGE code on the accompanying tag resulted in the issuance of a certificate of airworthiness without the benefit of complete and adequate documentation.

Air Asia Company Ltd. has taken safety action to ensure that the quality control within its maintenance facility is maintained by identifying and segregating military parts from commercial ones.

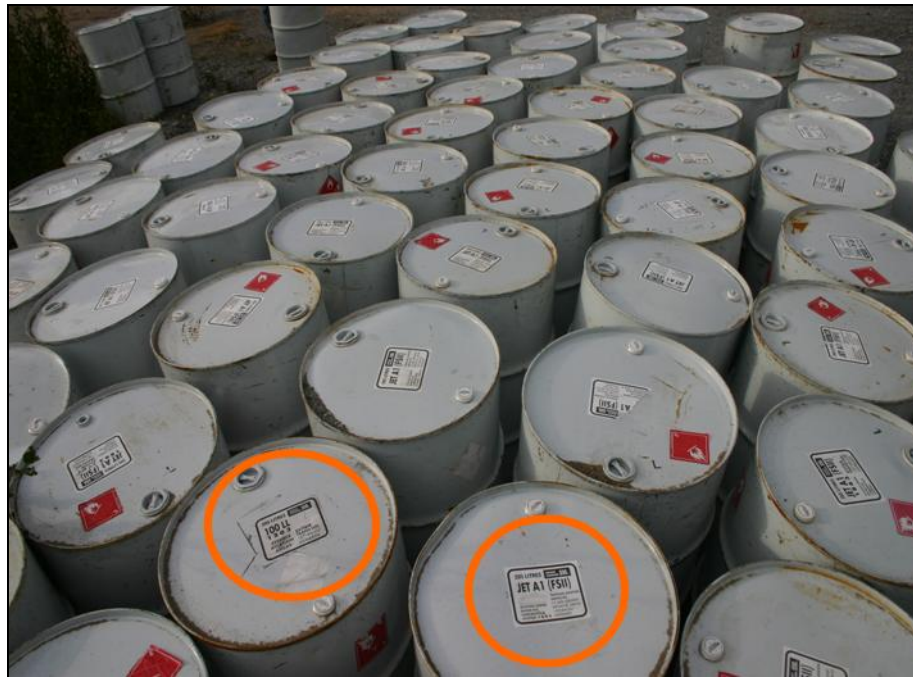
The Société de protection des forêts contre le feu (SOPFEU) is responsible for the prevention, detection and suppression of forest fires in Quebec. During forest fire suppression operations, the SOPFEU will order fuel from the closest fuel wholesaler. Barrels are used, cleaned, refilled, and resealed at the wholesaler's distribution yard and then delivered to the customer. Because the wholesaler is delivering a product to an off-airport location, it need only abide by provincial regulations. An order of 40 barrels of Jet A1 fuel was placed by the SOPFEU on 15 July 2005 with the wholesaler in Sept-Îles, Quebec, about 100 km from the base camp. However, 36 barrels of Jet A1 fuel and 4 barrels of AVGAS were delivered. The 40 barrels delivered were white in colour. The identifying stickers are white with black lettering. The markings on the identifying stickers affixed to the barrels showed the appropriate information specified in provincial regulations, in that they included type of fuel, date, batch number, and dangerous goods information. The only visible difference on the barrels were the words 100LL AVGAS and JET A1 (Photos 3 and 4).

**Photo 3.** View of fuel barrels and identifying stickers

Although the fuel product identifying stickers met provincial regulations, the similarity between the stickers may lead to misidentification of the fuel product. Operating with a small amount of AVGAS had no consequence on engine performance.

On 05 June 2006, the TSB issued Safety Information Letter A060026-1, Inadequate Identification of Fuel Barrels, to the Director General of Civil Aviation. The Safety Information Letter highlighted the criticality of proper identification of fuel barrels. The use of fuel barrels for remote helicopter operations is widespread throughout Canada.

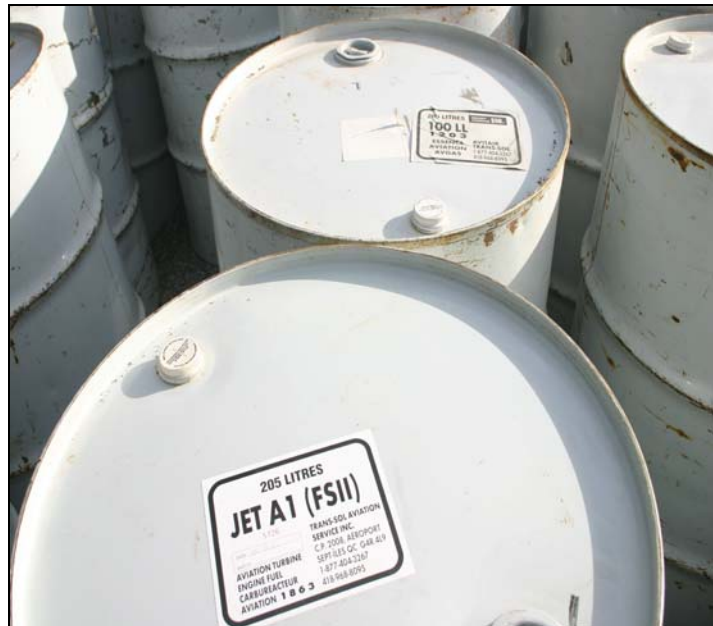
AVGAS is considered a Class 1 petroleum product and under existing provincial regulations, a Class 1 product over 45 litres does not require any kind of colour coding of the container. However, a container under 45 litres, containing a Class 1 product, must be predominately red in colour. Therefore, by provincial law, the 205-litre barrels of AVGAS do not have to differ in colour from a Class 2 (Jet

**Photo 4.** Fuel barrel identifying stickers

fuel) or a Class 3 product. No colour differentiation of the identifying stickers is necessary. The different products in the containers were not visible to the user, and do have a different colour and smell. AVGAS is blue and Jet fuel is yellow. Workers loading the product at the wholesaler and those delivering the product to the SOPFEU had mistakenly mixed some AVGAS barrels with the Jet A1 barrels. During the fuelling process, the helicopter pilots using the product mistakenly identified the AVGAS barrels as Jet A1 barrels.
